SAFETY INSPECTION REPORT

Date: 18.12.2025

PROJECT NAME	LEAD INSPECTOR
Project XYZ	EHS Manager
PARTICIPANTS	Project Manager, Site Manager, Foreman

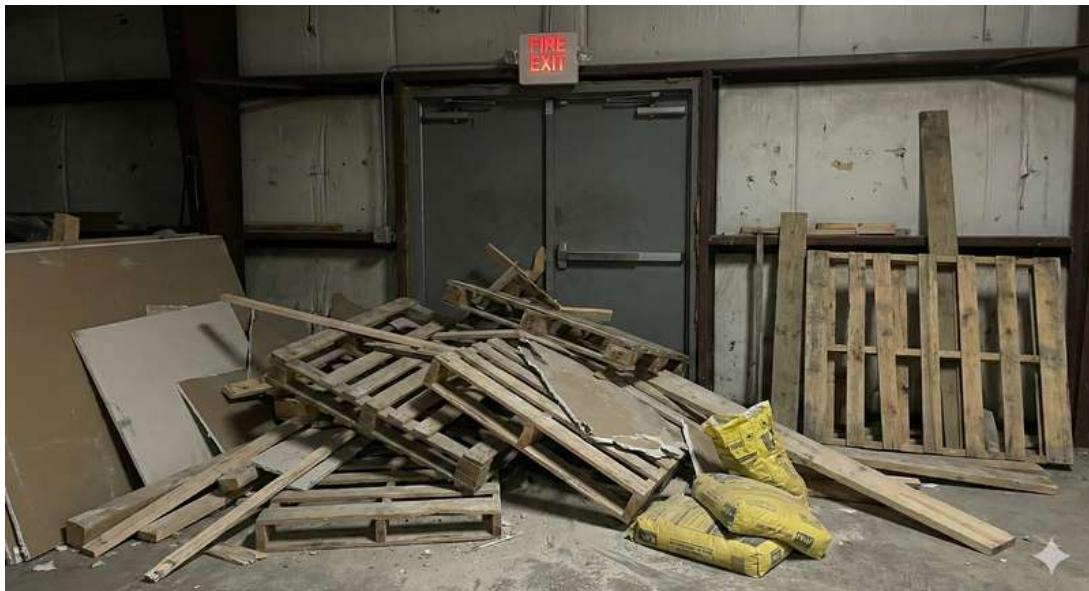
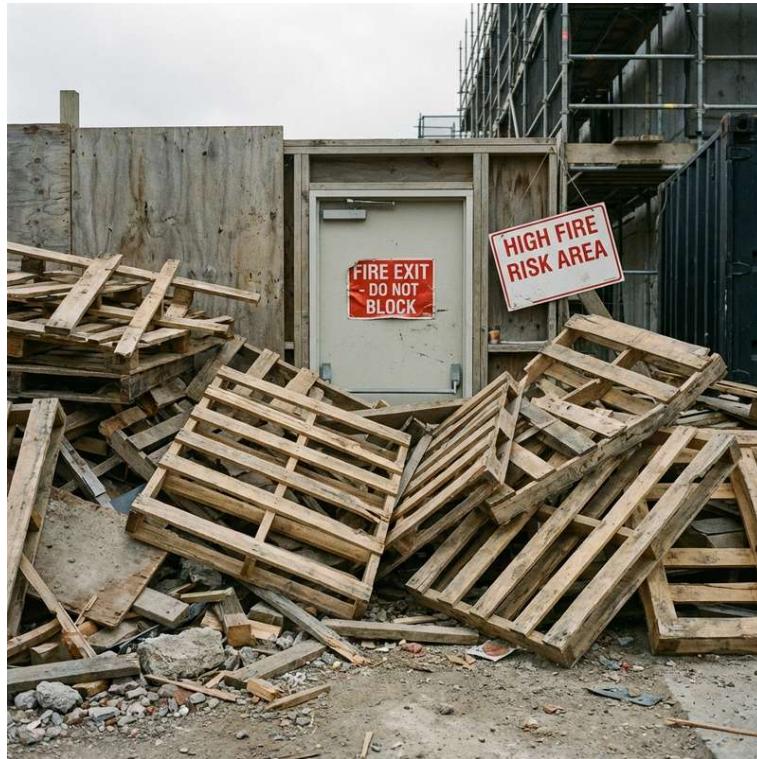
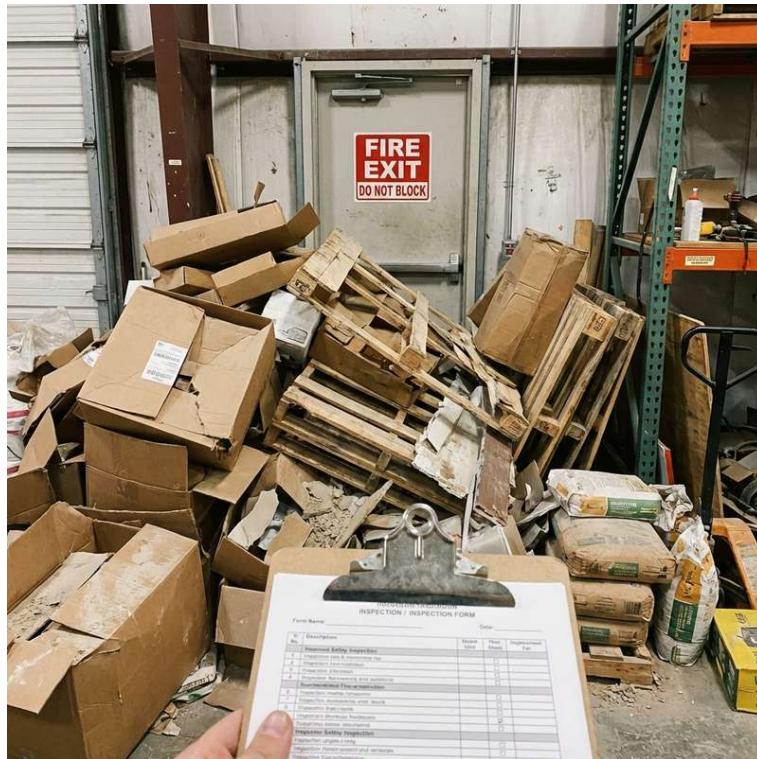
1. Blocked Fire Exit

Potentially Serious

A fire exit was completely blocked by a large pile of wooden pallets and other debris, preventing its use in case of emergency. A 'FIRE EXIT' sign is visible above the door, but access is obstructed. This poses a significant safety hazard and violates fire safety regulations.

Immediately clear the fire exit and ensure it remains unobstructed at all times. Implement procedures to prevent future blockage.

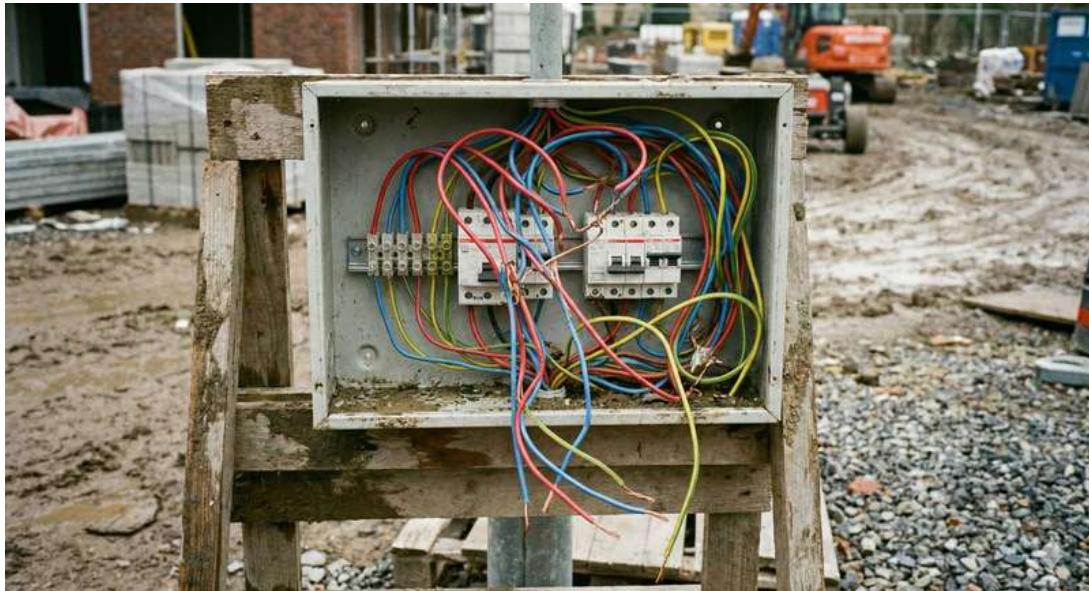
2. Exposed Electrical Wires

Critical

The cover of an electrical distribution board is missing, exposing live electrical wires. This creates a significant risk of electric shock. The wires are various colors (red, blue, yellow, green) and some are not connected, hanging loosely. An orange excavator is in the background.

Immediately replace the missing cover and ensure all electrical boxes are properly enclosed and secured. Verify proper wire terminations and insulation.

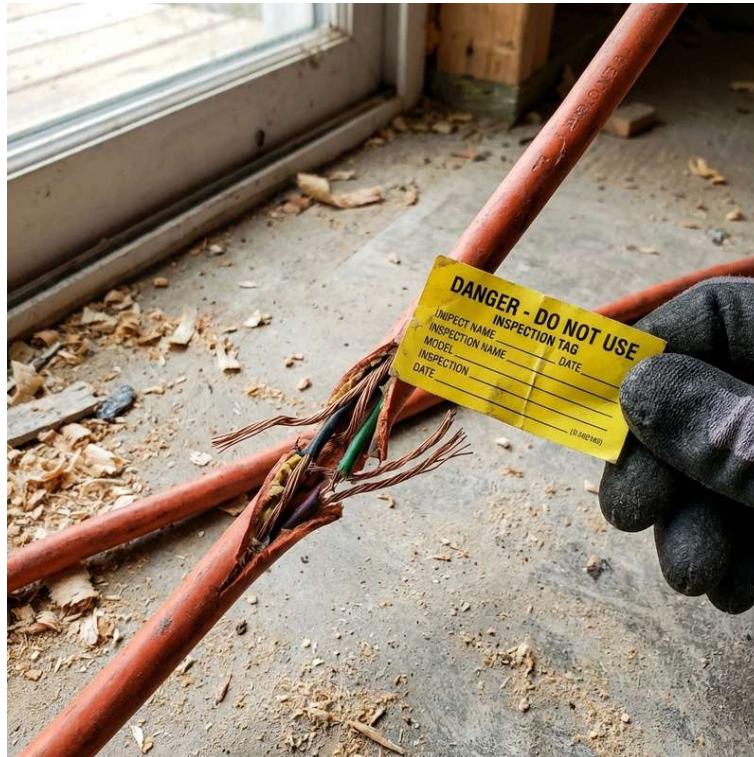
3. Damaged Copper Cable

Potentially Serious

A copper cable is exposed, indicating damage to the cord. A 'DANGER - DO NOT USE' tag is attached, indicating it has already been identified as unsafe. The outer jacket of an orange extension cord is torn open, exposing the internal wiring.

Remove the damaged cable from service immediately. Replace with a new, properly insulated cable. Ensure all damaged cords are tagged out and disposed of correctly.

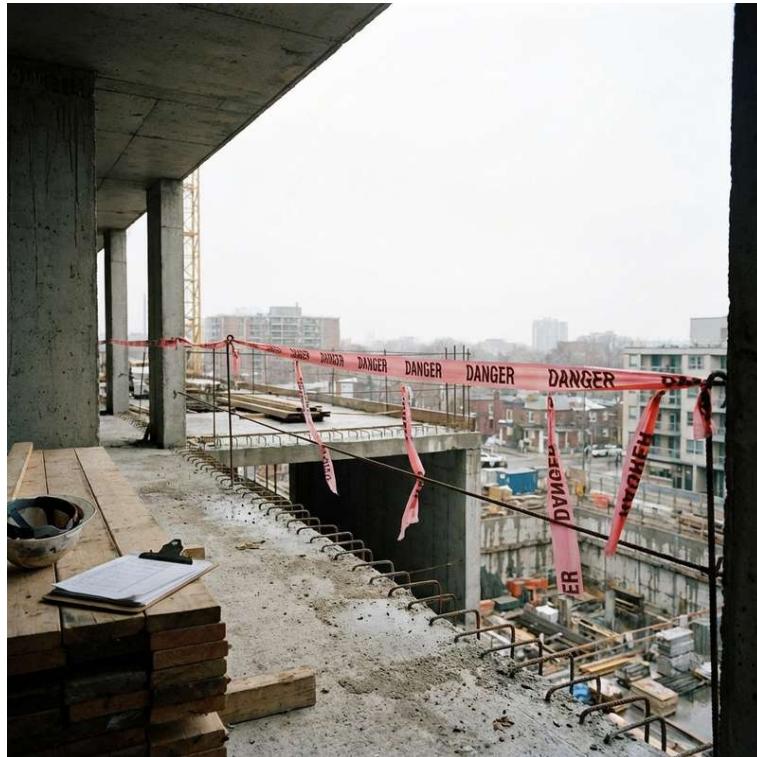
4. Missing Balcony Guardrail

Critical

There is no guardrail on a balcony on the 4th floor, creating a significant fall hazard. Pink 'DANGER' tape serves as a barrier along the open edge of the concrete floor. Reinforcement bars extend upward from the concrete. The concrete is damp.

Install a guardrail or other suitable fall protection measures immediately. Restrict access to the balcony until fall protection is in place.

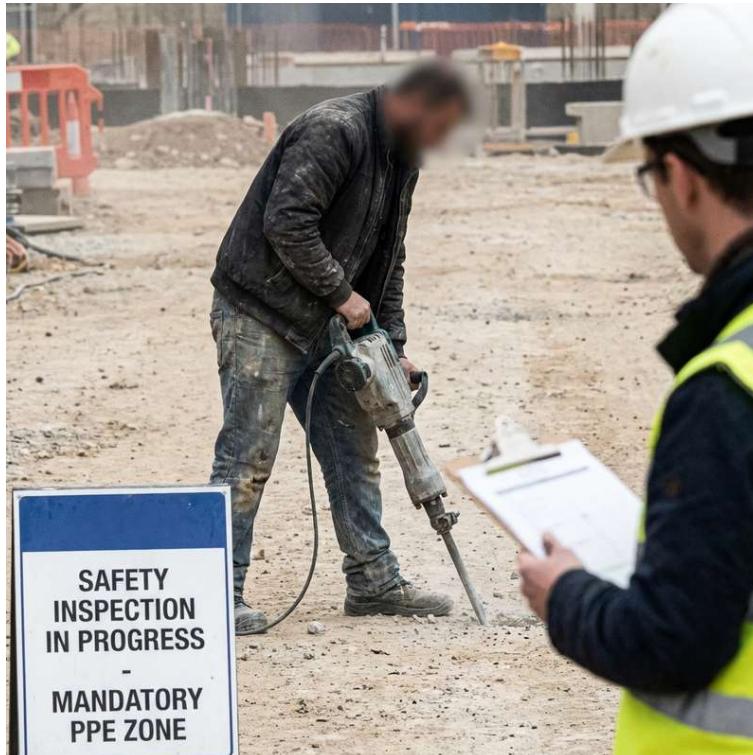
5. Lack of PPE - Jackhammer

Potentially Serious

A worker is using a jackhammer without proper PPE, specifically a helmet or earplugs. While a sign reads 'SAFETY INSPECTION IN PROGRESS' and 'MANDATORY PPE ZONE', the worker is not in compliance. He's wearing jeans, a black jacket, and work boots, but lacks appropriate head and hearing protection.

Immediately stop the work and ensure the worker is provided with and uses the correct PPE (helmet, earplugs, and safety glasses). Enforce PPE requirements for all tasks.

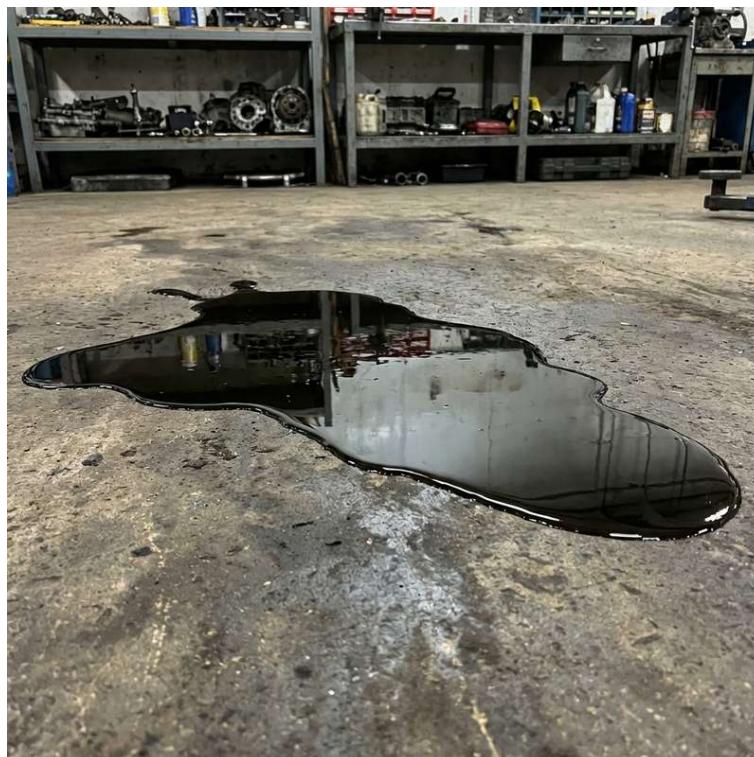
6. Oil Spill Hazard

Potentially Serious

A large oil spill is present on the workshop floor, creating a slip and fall hazard. There is no cleanup or warning sign posted. The oil is black and reflects objects from the shelving in the background. The floor is stained and discolored.

Clean up the oil spill immediately and implement procedures to prevent future spills. Place warning signs in the area until the spill is cleaned. Provide spill cleanup kits.

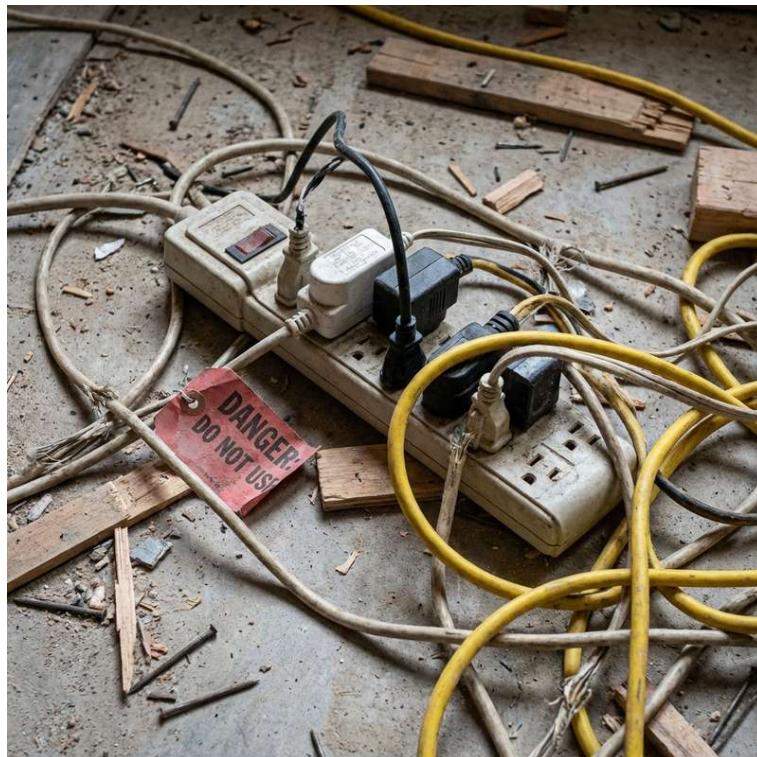
7. Overloaded Power Strips

Potentially Serious

Power strips are plugged into other power strips, creating a fire hazard due to potential overload. An overloaded power strip with multiple plugs is lying on a dirty floor with a 'DANGER: DO NOT USE' tag partially obscured.

Remove the overloaded power strips and use proper electrical outlets. Ensure power distribution is adequate and does not exceed the capacity of the circuits.

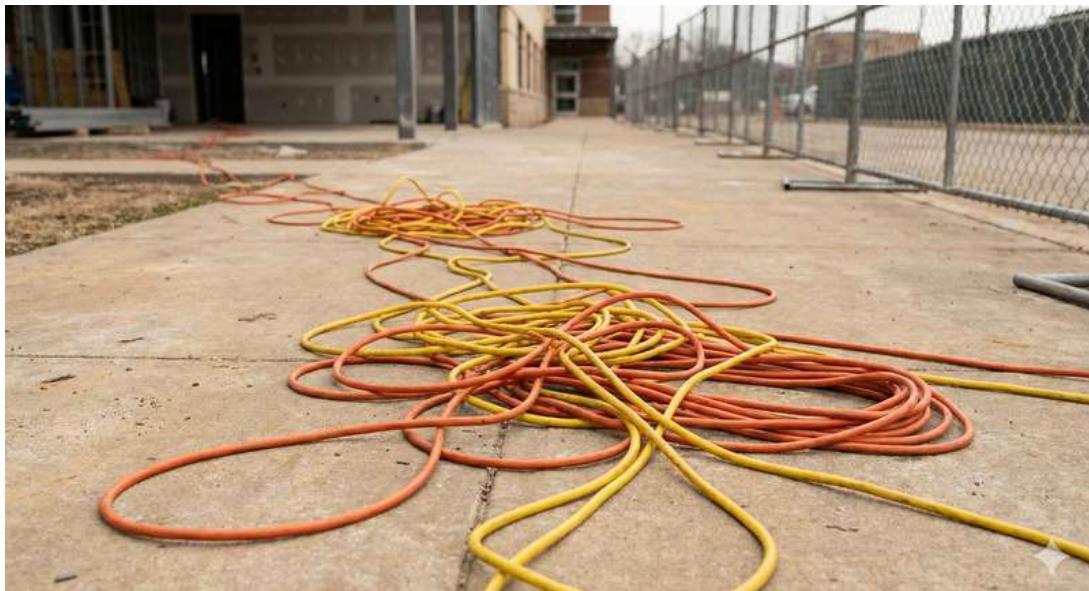
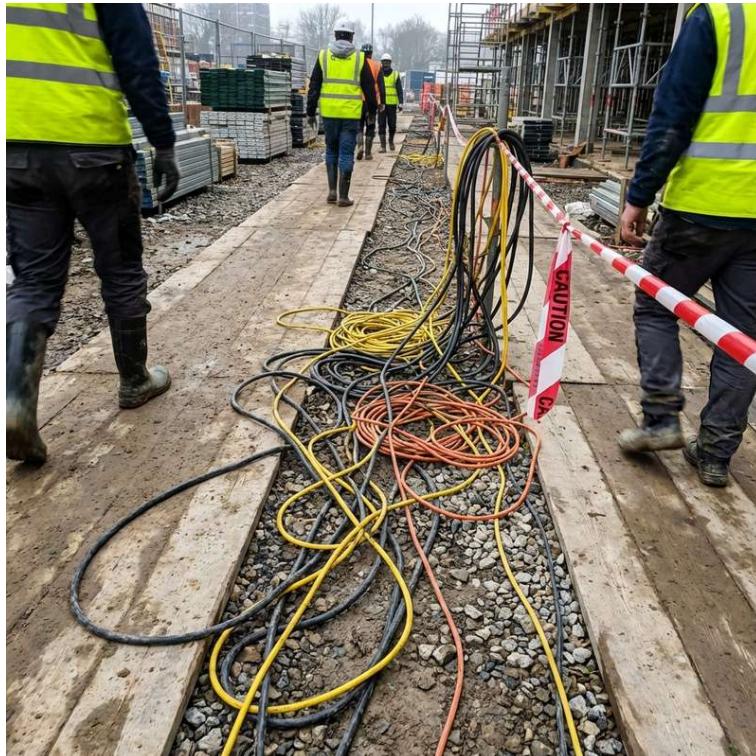
8. Cables Trip Hazard

Major

Electrical cables are spread across walkways, creating a tripping hazard. Multiple colored extension cords are tangled on the ground. Workers in high-visibility vests and boots are walking near the cords. The hallway is partially blocked by a pile of materials, including bags of cement, wooden pallets, and loose debris with electrical cords strewn amongst it. Yellow and orange extension cords are tangled and sprawled across a concrete surface.

Secure the cables using tape or cable ties to prevent tripping hazards. Implement a cable management plan.

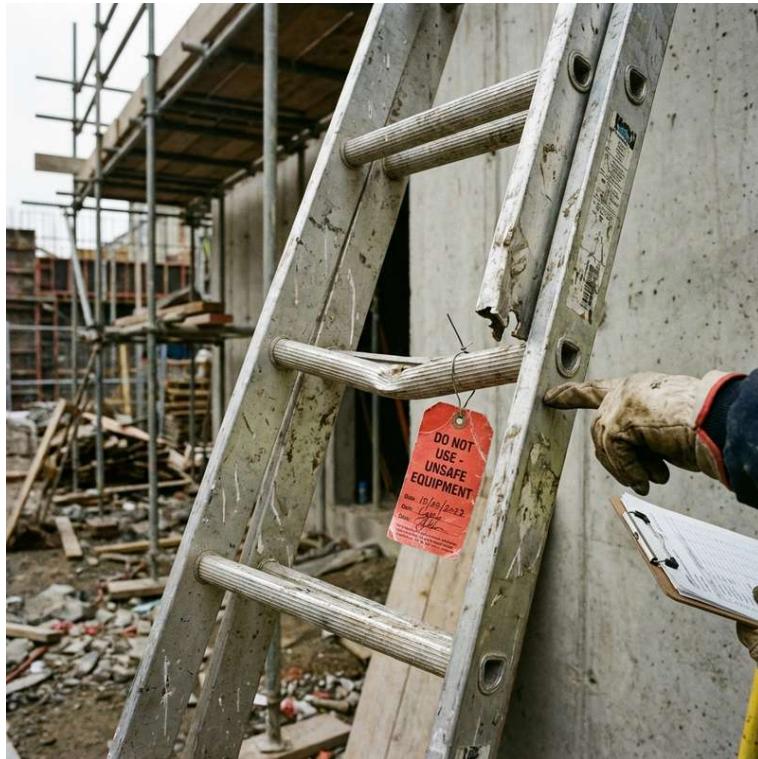
9. Damaged Ladder Rungs

Major

The aluminum ladder has bent and broken rungs, rendering it unsafe for use. A red 'DO NOT USE UNSAFE EQUIPMENT' tag is attached, dated '10/23/2023'.

Remove the damaged ladder from service and replace it with a new, safe ladder. Dispose of the damaged ladder properly.

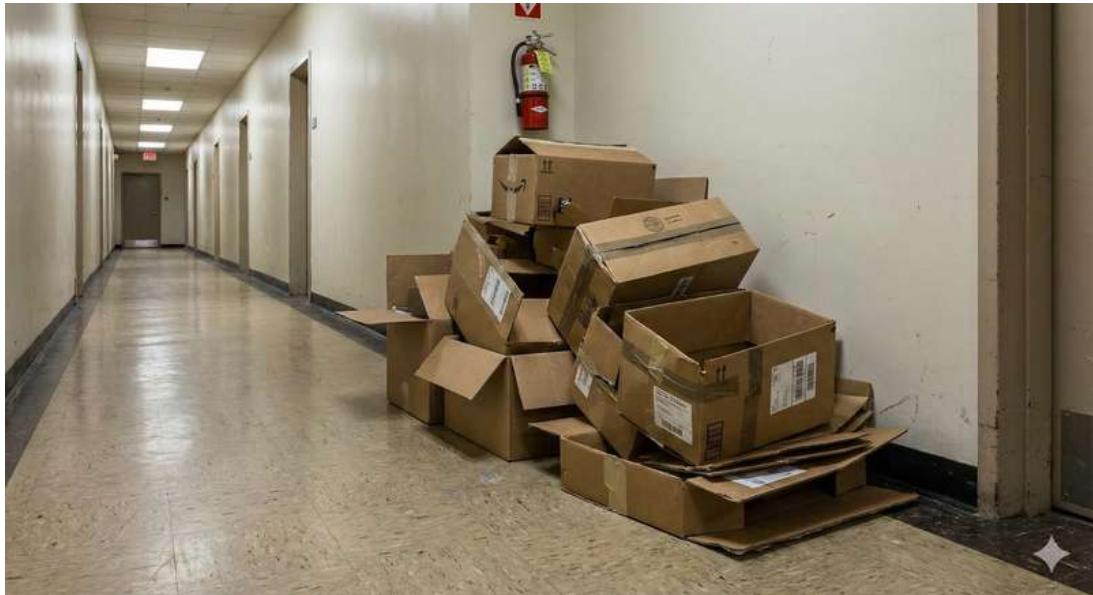
10. Obstructed Fire Escape

Potentially Serious

The corridor is full of lumber, blocking access to the fire escape. Flattened cardboard boxes are partially blocking the hallway. A fire extinguisher is mounted on the wall above the boxes.

Clear the corridor and fire escape immediately. Ensure fire escape routes are kept clear at all times.

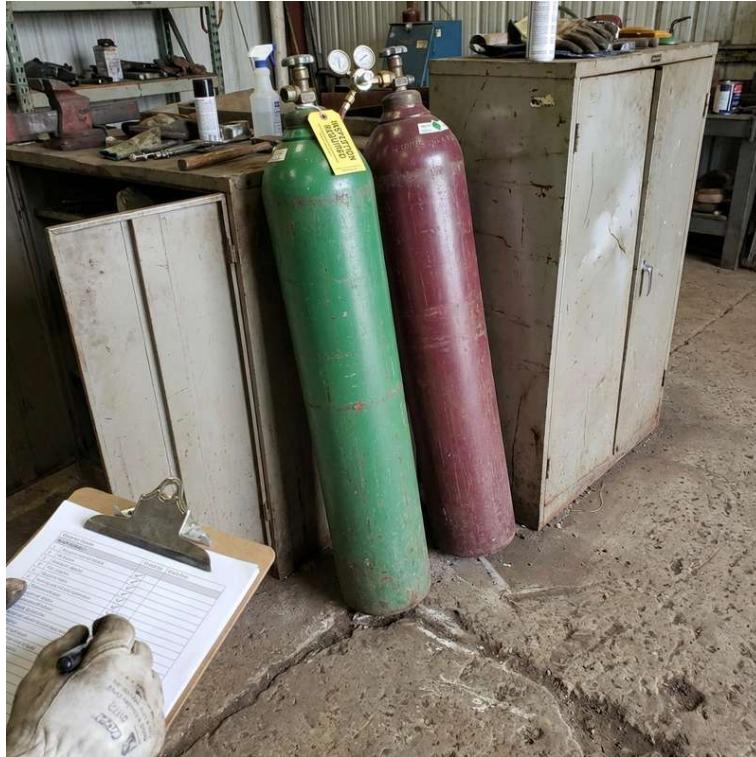
11. Unsecured Gas Cylinders

Critical

Gas cylinders are standing loose and are not chained, posing a risk of them falling over. Two gas cylinders, one green and one maroon, are leaning against a gray metal cabinet. A clipboard with a checklist is resting against the green cylinder, which is labeled 'OXYGEN'.

Secure all gas cylinders with chains or other suitable restraints to prevent them from falling over. Ensure cylinders are stored in a designated, well-ventilated area.

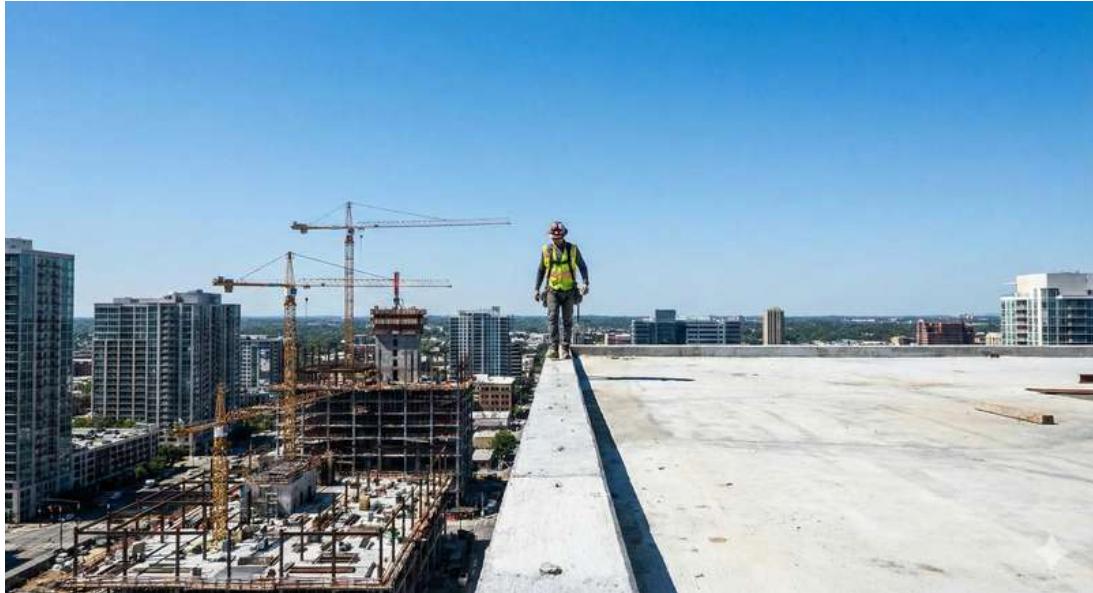
12. Roof Work No Harness

Critical

A worker is on the roof edge without a harness, presenting a severe fall risk. The worker is wearing a hard hat, reflective vest, and safety harness is walking along the edge of a tall building under construction. There are no visible guardrails or fall protection measures in place other than the worker's harness, which may or may not be properly attached.

Stop work immediately and ensure all workers on the roof are using proper fall protection equipment, including harnesses and lifelines. Provide fall protection training.

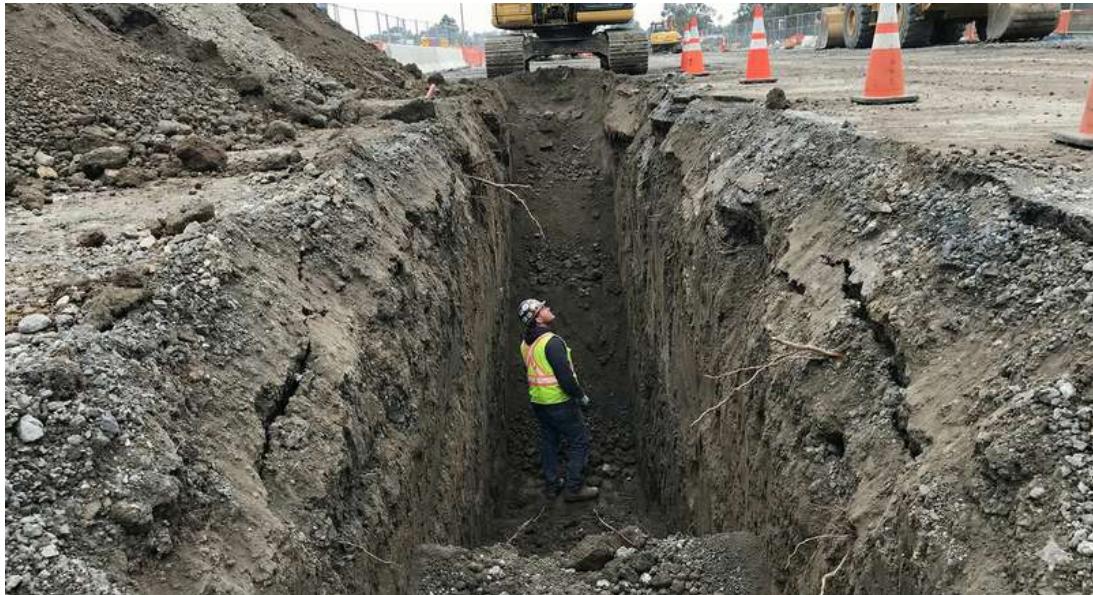
13. Unshored Trench

Critical

A worker is in a trench with no shoring, and the walls appear unstable, posing a collapse risk. The worker is wearing a yellow safety vest and a hard hat. Heavy machinery, including an excavator, is visible at the top of the trench. The trench appears to be unsupported.

Remove the worker from the trench immediately. Implement proper shoring or sloping techniques to stabilize the trench walls before any further work is conducted.

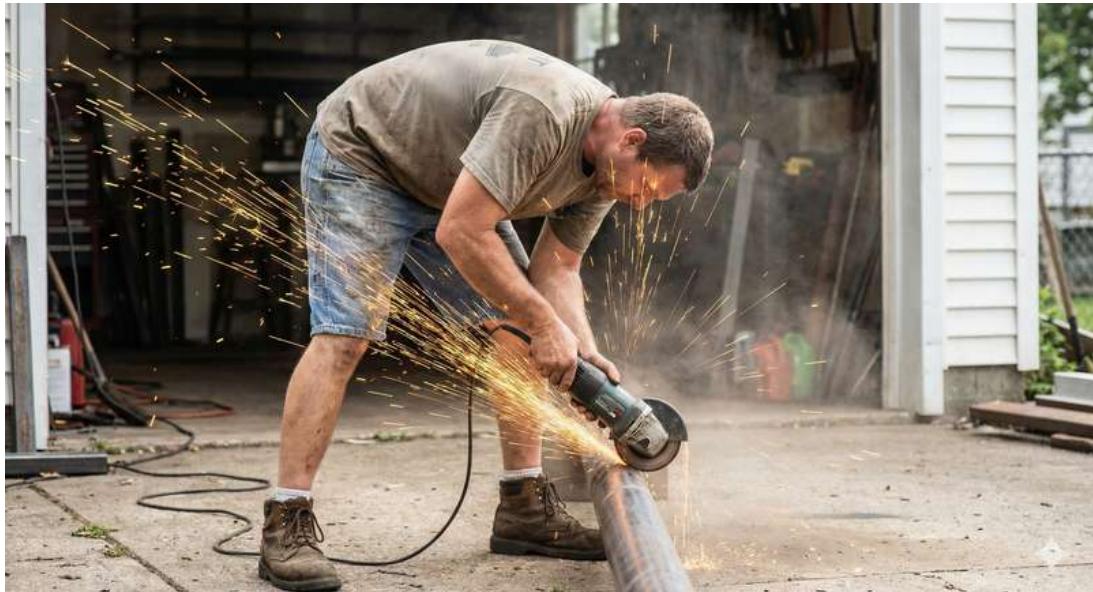
14. Grinding No PPE

Critical

A worker is grinding steel without proper eye protection. Sparks are flying in all directions. He is wearing a t-shirt, denim shorts, work boots, and eye protection, but no other personal protective equipment. The pipe appears to be resting directly on the concrete floor.

Stop work immediately and ensure the worker is wearing appropriate PPE, including a face shield, gloves, and protective clothing.

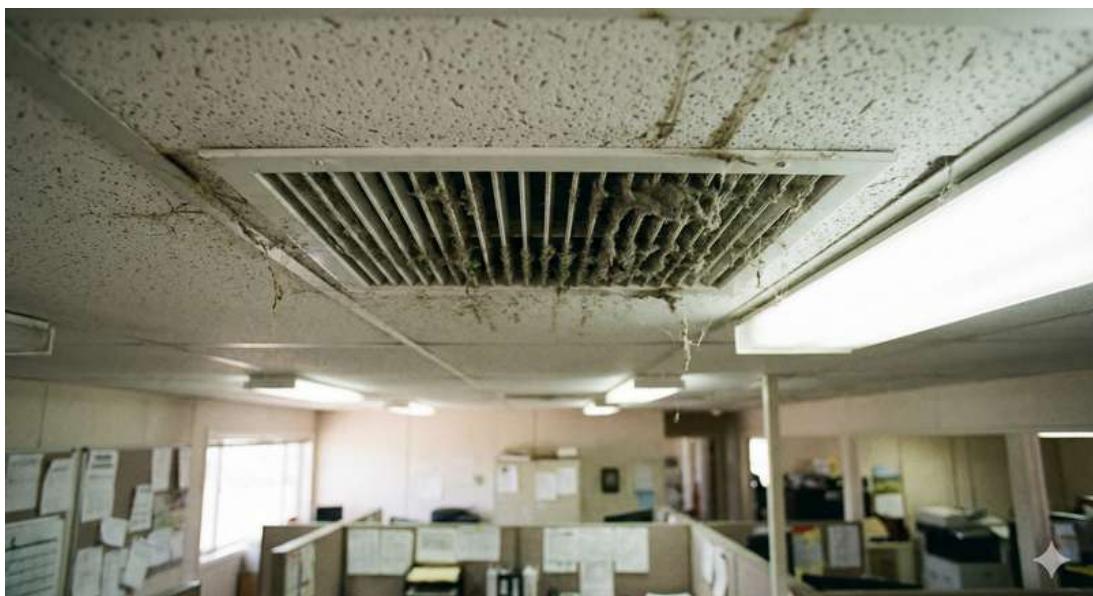
16. Filthy AC Vent

Minor

The AC vent is filthy and needs cleaning due to dust buildup. The surrounding ceiling tiles are also stained and dirty. The office space below is visible and appears to be occupied with cubicles.

Clean the AC vent and surrounding area to improve air quality and prevent potential health hazards.

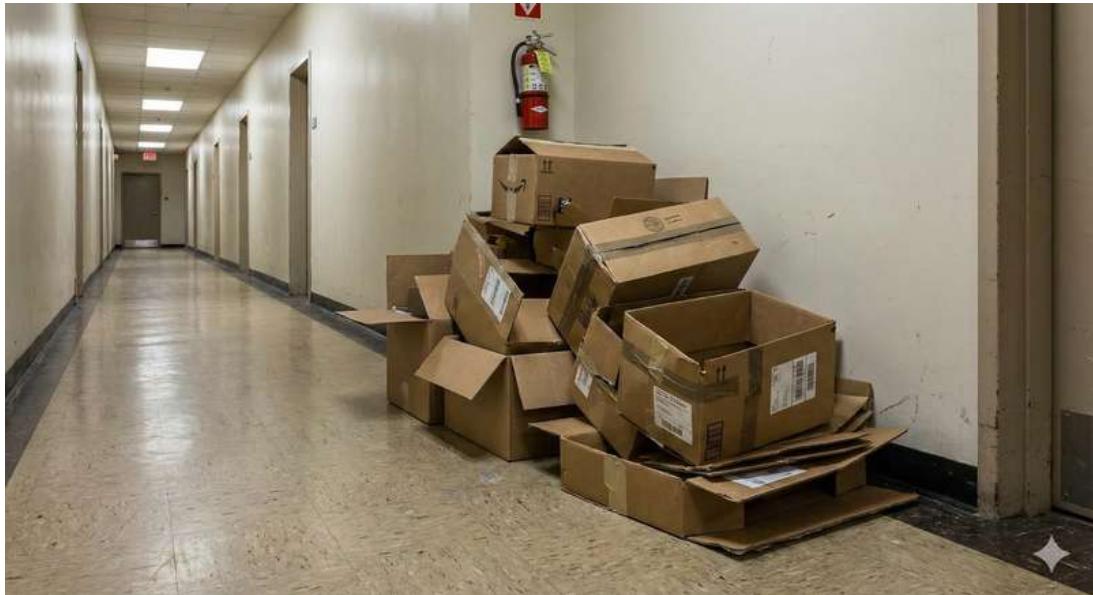
17. Rubbish Accumulation

Minor

Rubbish, including empty boxes, is left in a corner and needs to be cleared up. A hallway is partially blocked by a pile of flattened cardboard boxes.

Remove the rubbish and implement a regular cleaning schedule to maintain a tidy workspace.

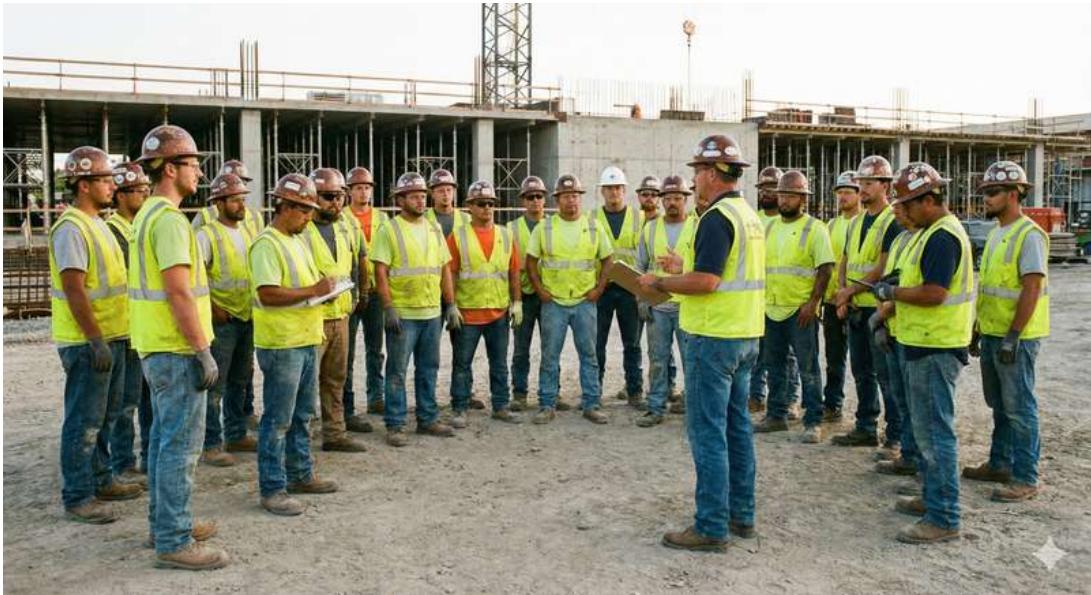
18. Good Toolbox Talk

Positive Observation

Good toolbox talk attendance with everyone in full PPE is a positive observation. A group of construction workers, all wearing hard hats and reflective vests, are gathered in a circle. One worker is standing in the center holding a clipboard and appearing to give instructions.

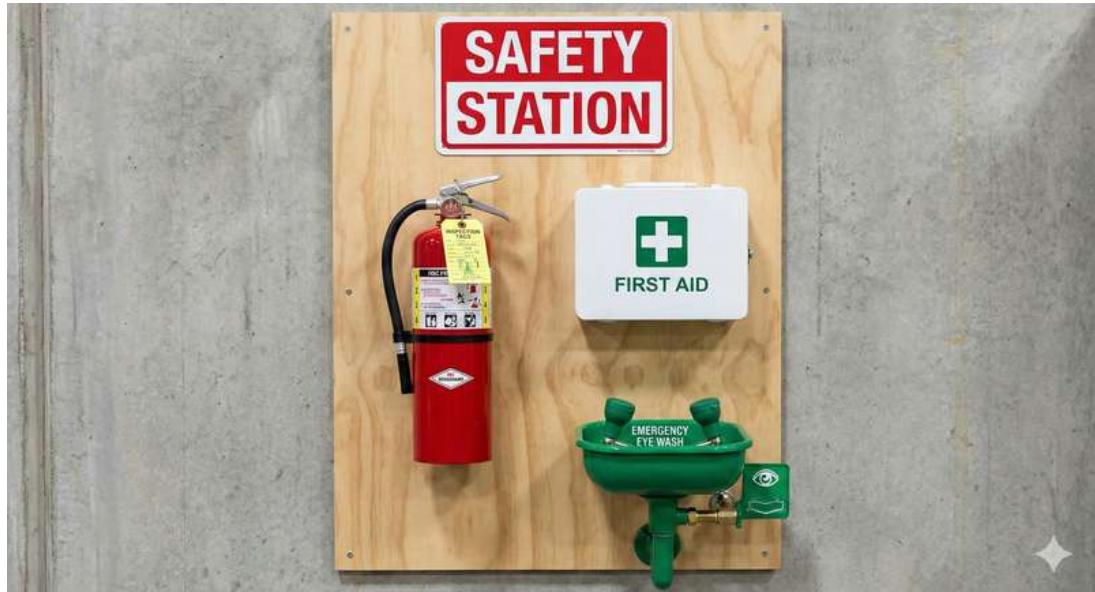
19. Well-Stocked Safety Point

Positive Observation

The safety point is fully stocked and has clear access, which is a good job. A safety station is mounted on a wooden board against a gray wall. The station includes a red fire extinguisher, a white first aid kit with a green cross, and a green emergency eyewash station.

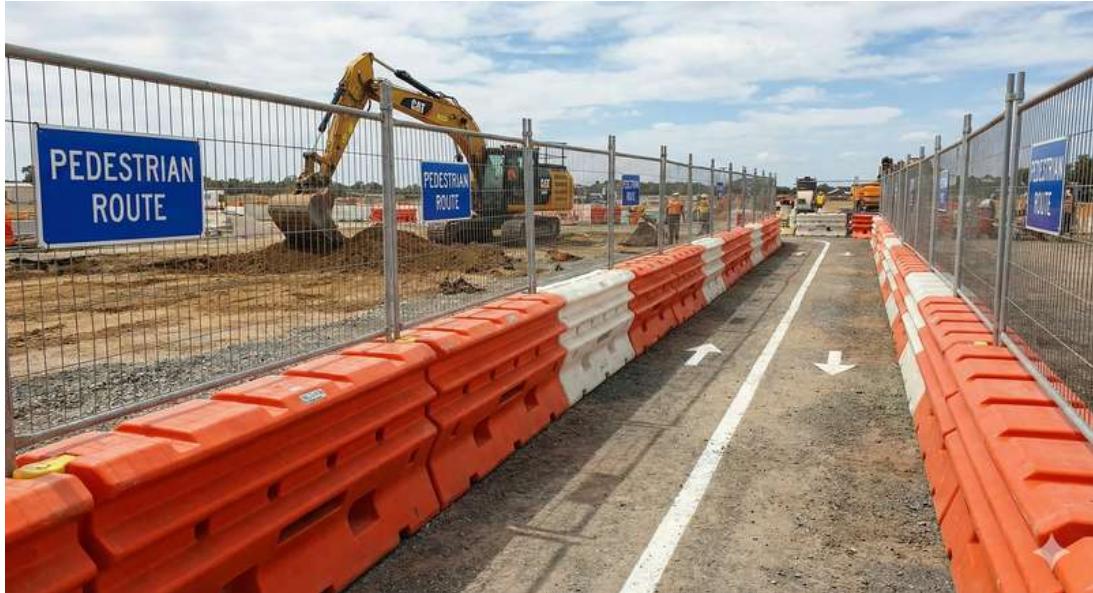
20. Good Vehicle Separation

Positive Observation

Plant vehicle separation is well-managed with good barriers in place and a safe route designated. A construction site shows a designated pedestrian route marked by blue signs reading 'PEDESTRIAN ROUTE' on both sides. The route is bordered by orange and white water-filled barriers, and fenced off with metal mesh fencing.

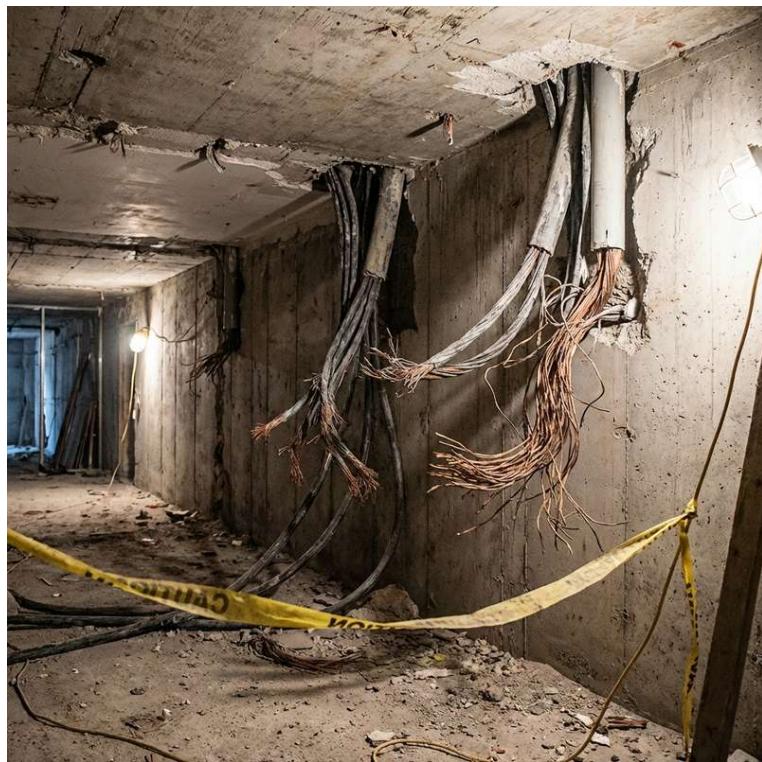
21. Exposed Cables Hallway

Major

Exposed electrical cables hanging from the ceiling in a dimly lit, unfinished interior hallway. The cables are a mix of grey, black, and brown, with stripped ends. Yellow caution tape is stretched across the foreground. The floor is littered with debris and appears to be concrete. Lighting fixtures are present on the walls.

Secure or remove the exposed cables and ensure all electrical wiring is properly insulated and protected.
