# SAFETY INSPECTION REPORT

Date: 27.07.2026

**Northgate Logistics Hub — Phase 2**

**J. Eriksson, EHS Manager**

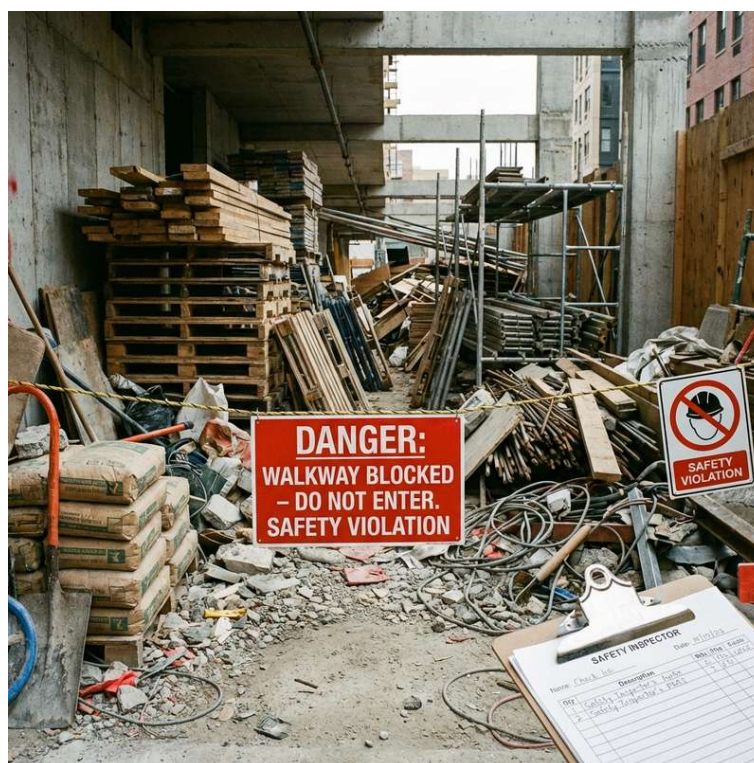
## 1. Blocked Fire Exit

A designated fire exit is completely obstructed by stacked wooden pallets and construction debris. The corridor leading to the escape is also filled with lumber and cardboard, making the exit route obscured and impassable in an emergency.

Clear all pallets and debris from the exit immediately. Establish a permanent 'no-storage' zone in front of all emergency exits and mark the floor with yellow hatching to prevent future blockages.

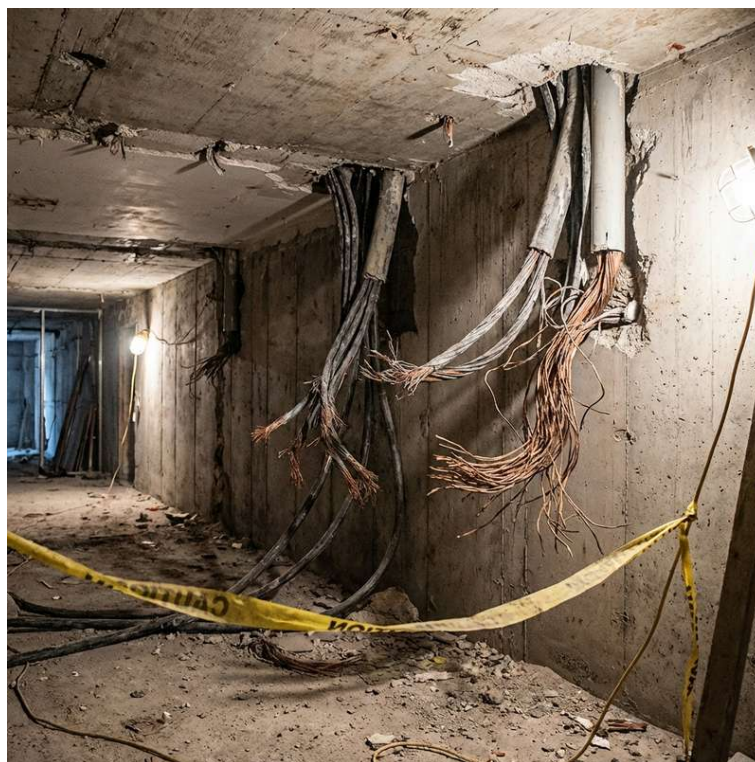
## 2. Exposed Live Wires

The cover for an electrical distribution board is missing, leaving live wires exposed. Additionally, bundles of frayed electrical wires are hanging from ceiling openings in a concrete corridor where caution tape has been placed, but the hazard remains active.

Stop all work in the vicinity. The electrical foreman must replace the distribution board cover and properly terminate or secure all hanging wires in accordance with EN 50110-1 standards.

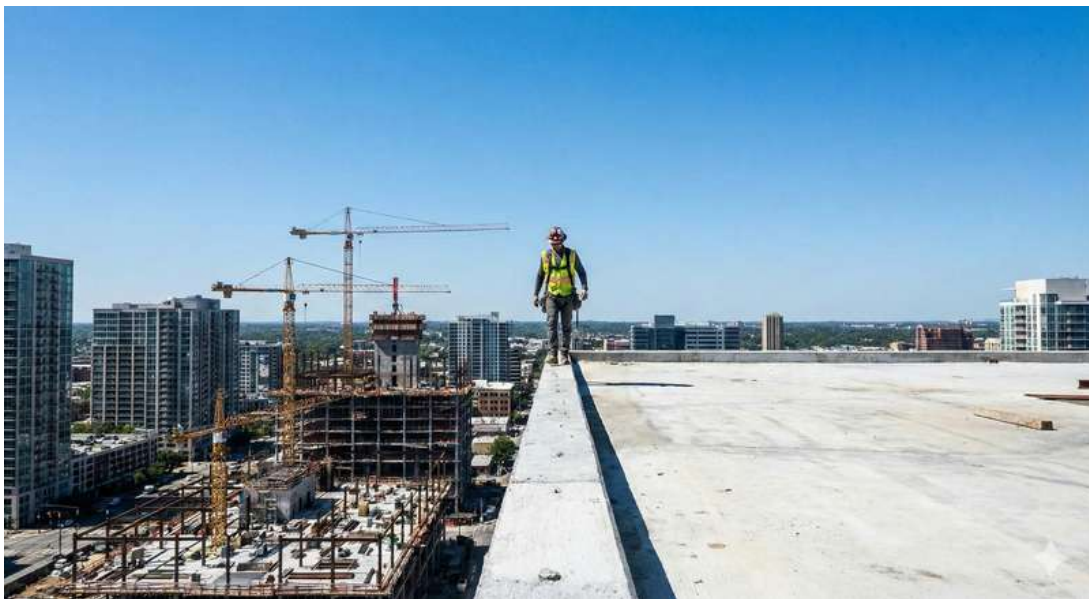
### 3. Unprotected Roof Edge

A worker was observed at the roof edge without a safety harness or any form of fall arrest system. This is a direct violation of working at height regulations.

Stop work on the roof immediately. Ensure all personnel are trained in fall protection and that 100% tie-off is enforced. Install temporary guardrails if work near the edge is to continue.

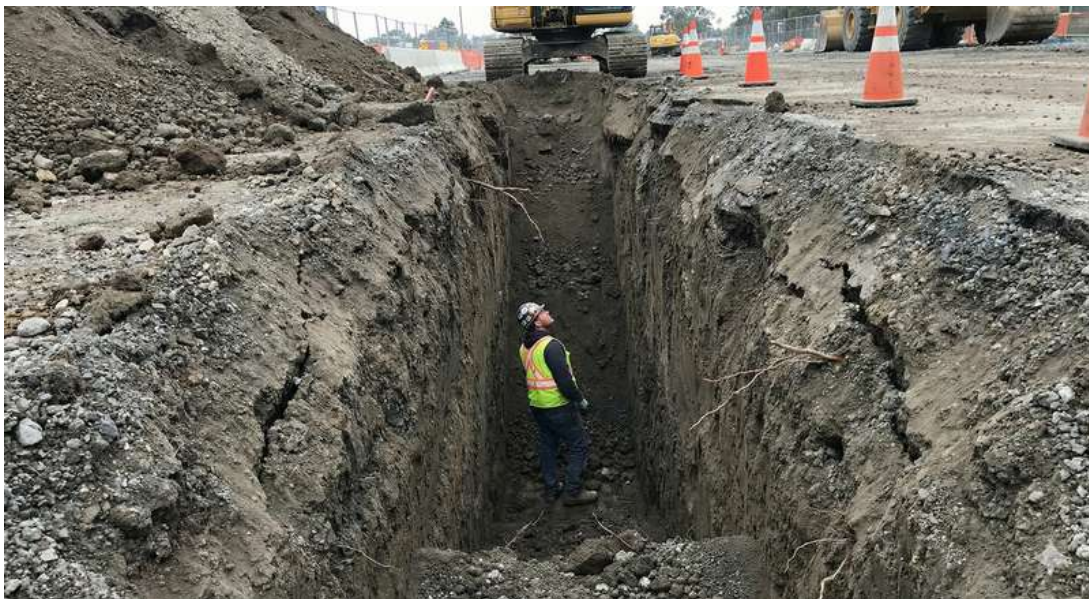
## 4. Unshored Trench Entry

A worker was found standing inside an unshored trench. The lack of trench boxes or shoring poses an immediate risk of cave and burial.

Evacuate the trench immediately. No entry is permitted until proper shoring, shielding, or sloping is installed and inspected by a competent person.

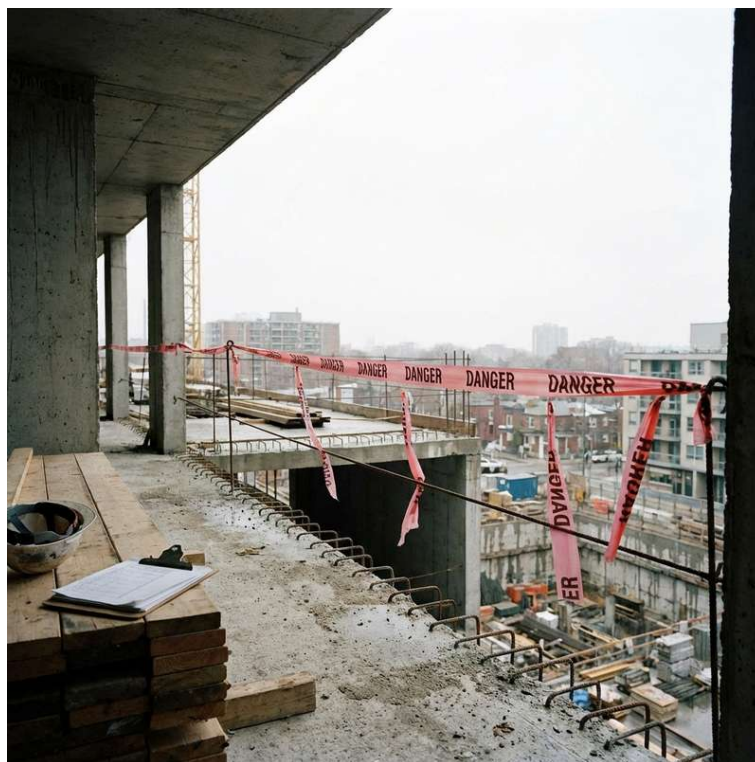
## 5. Missing Balcony Guardrail

The 4th-floor balcony has no structural guardrail. The area is only demarcated with pink tape, which provides no physical fall protection.

Restrict all access to the 4th-floor balcony. Install a compliant guardrail system with top rails, mid-rails, and toe boards before allowing work to resume in this area.

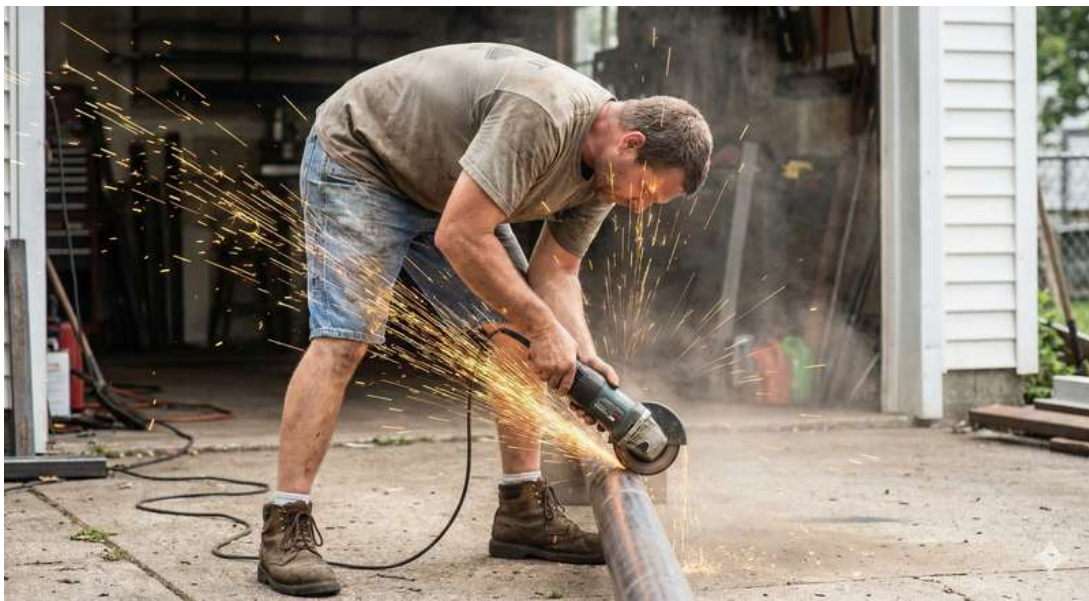
## 6. Unsafe Grinding Operations

A worker was observed grinding steel without a face shield, wearing only a t-shirt and shorts. Sparks were flying into the work area, creating a high risk of eye injury and skin burns.

Stop the grinding task. The worker must be equipped with a face shield, long sleeves, and flame-resistant trousers. Re-induct the worker on hot work PPE requirements.

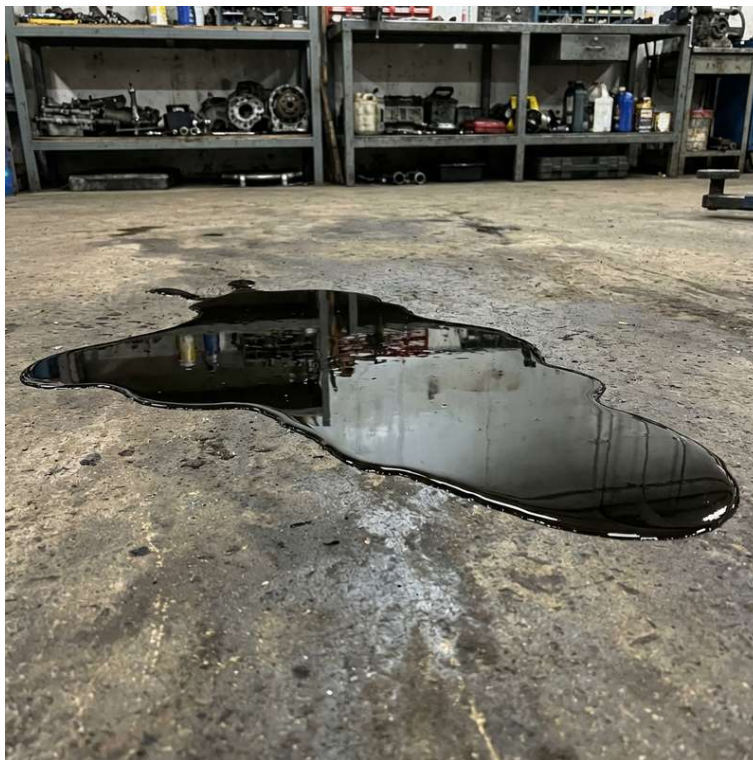
## 7. Large Oil Spill

A large, dark liquid spill is present on the concrete floor of the workshop near metal shelving units. There are no warning signs or spill kits deployed to manage the slip hazard.

Deploy absorbent materials to clean the spill immediately. Identify the source of the leak from the containers on the shelving and ensure all hazardous liquids are stored in bunded trays.

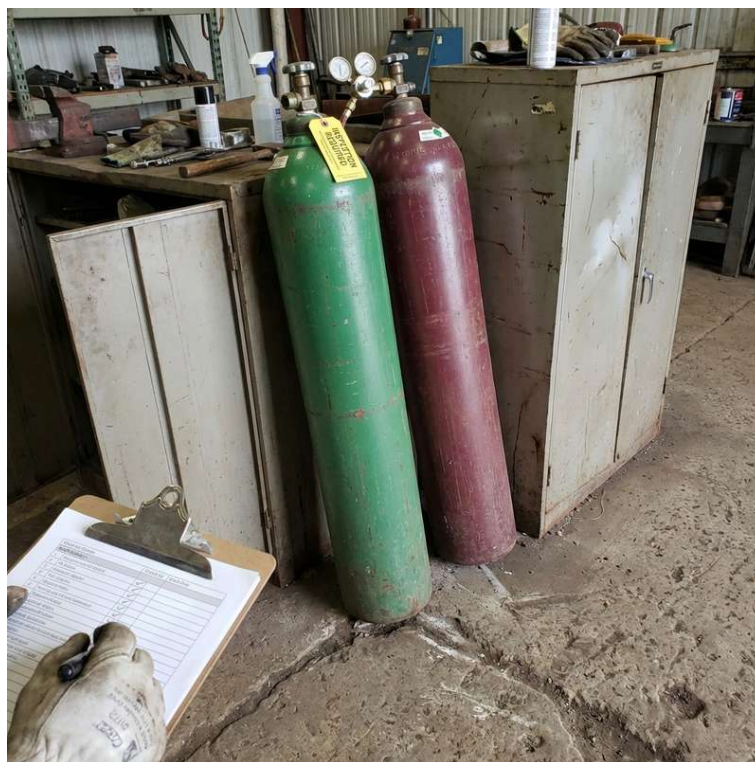
## 8. Unsecured Gas Cylinders

Oxygen and maroon (acetylene) gas cylinders are leaning against a cabinet without being chained or secured in an upright position. This creates a risk of the cylinders falling and the valves shearing off.

Secure all cylinders in an upright position using chains or a dedicated cylinder trolley. Store oxygen and fuel gases at least 6 meters apart or separate them with a fire-rated wall.

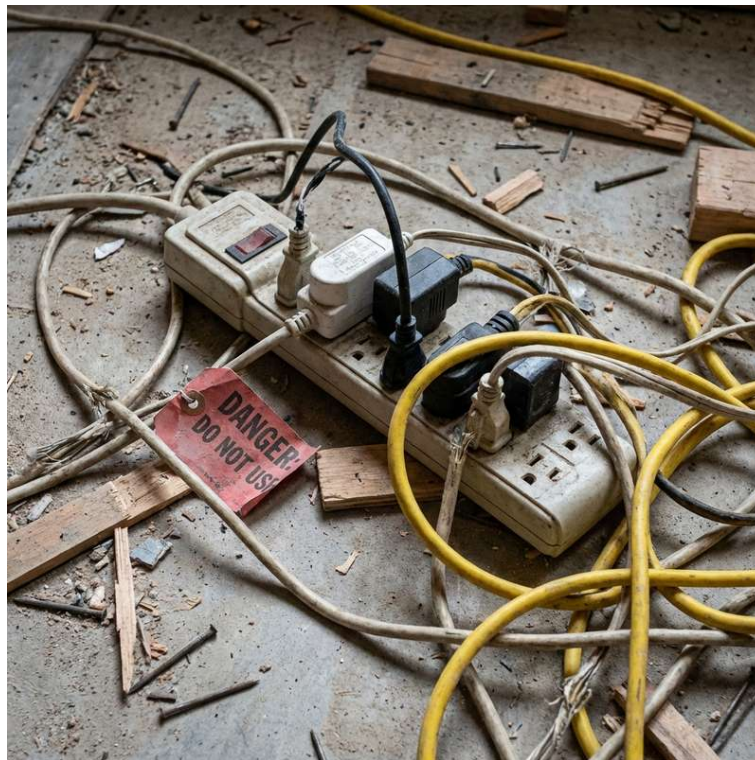
## 11. Daisy-Chained Power Strips

Multiple power strips are daisy-chained together on the floor. This practice can lead to circuit overload and is a known fire risk.

Disconnect the daisy-chained strips. Install additional permanent or temporary power outlets to meet the power demand without overextending the capacity of individual strips.

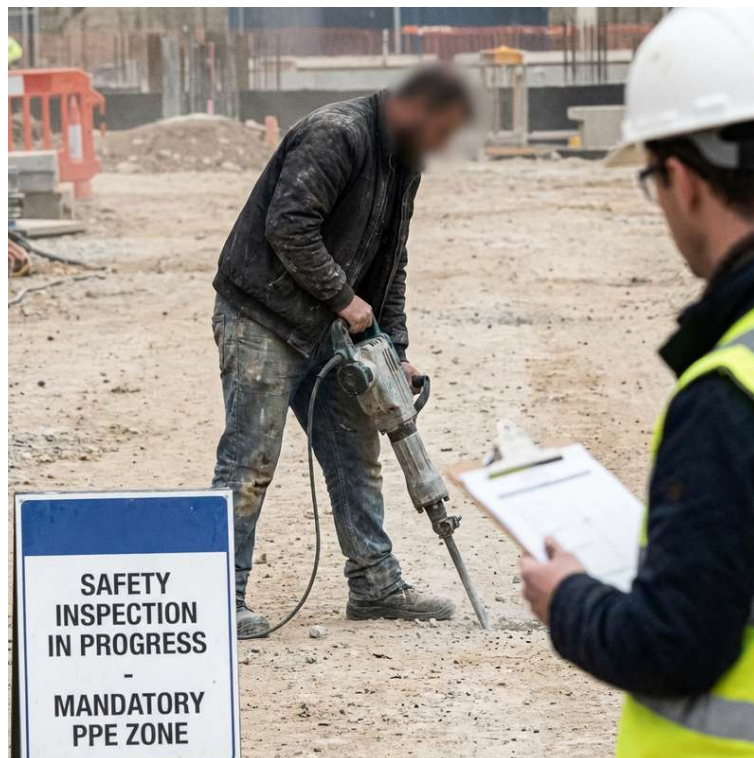
## 12. PPE Non-Compliance

A worker using a jackhammer was observed without a helmet or earplugs in a zone where PPE is mandatory.

The worker was stopped and instructed to wear the required PPE. Site supervisors must conduct more frequent spot checks to ensure compliance in high-noise and impact zones.

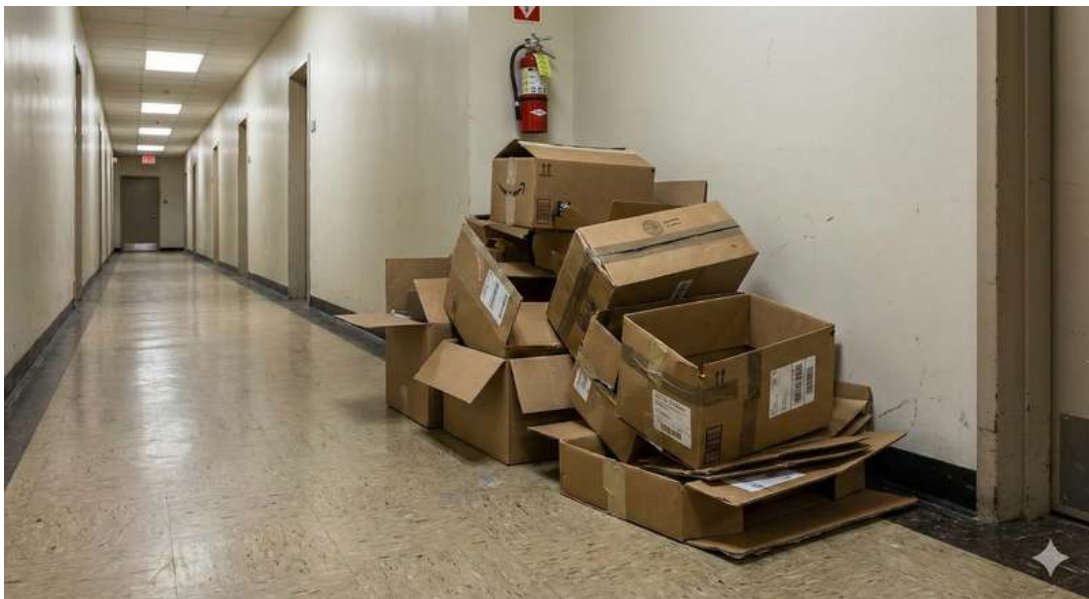
## 14. Poor Facility Maintenance

AC vents are filthy, ceiling tiles are stained, and rubbish is piled in corners. This indicates a lack of routine facility maintenance and cleaning.

Schedule a deep clean of the ventilation system and replace stained ceiling tiles. Implement a weekly rubbish removal schedule for all indoor areas.

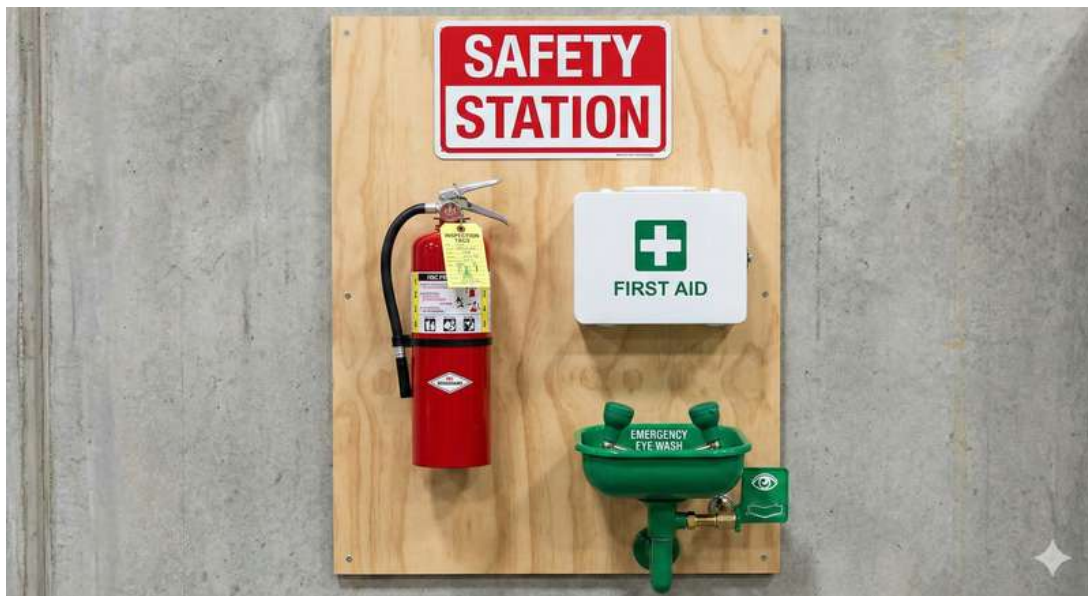
## 16. Well-Stocked Safety Point

The central safety point is fully stocked with fire extinguishers, first aid kits, and eyewash stations, all of which appear maintained.

Maintain the current inspection frequency for emergency equipment to ensure readiness.
